SANITARY SEWER SYSTEM COMPLIANCE INSPECTION

**CITY OF DURHAM,
NORTH CAROLINA**

INSPECTION REPORT

October 23 - 25, 2012

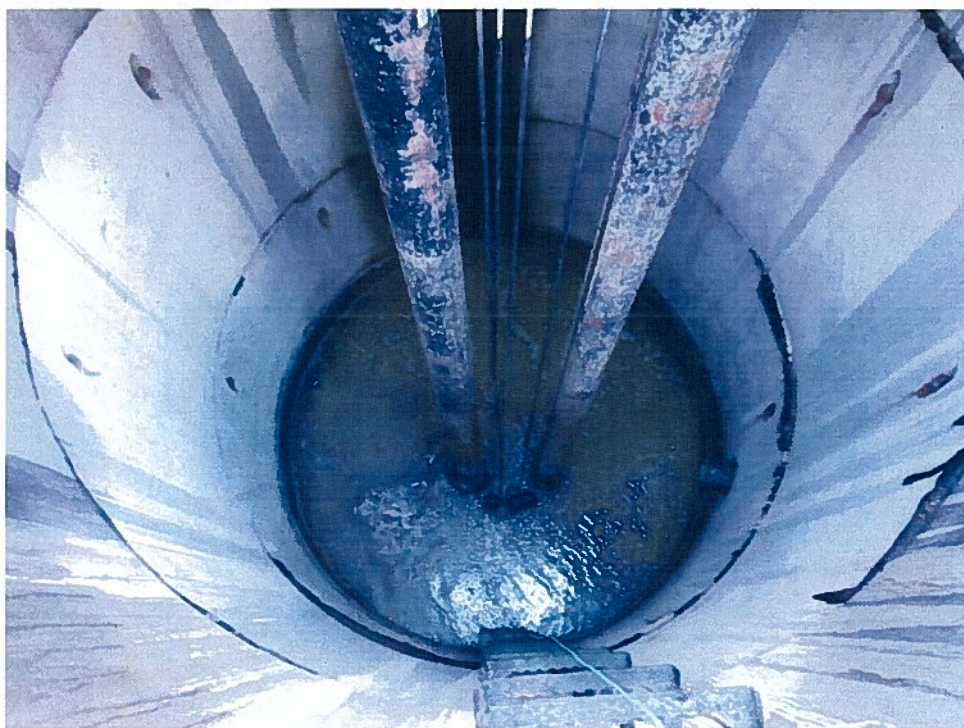
Photograph 4. Glenview Pump Station – View of pump station wet well.

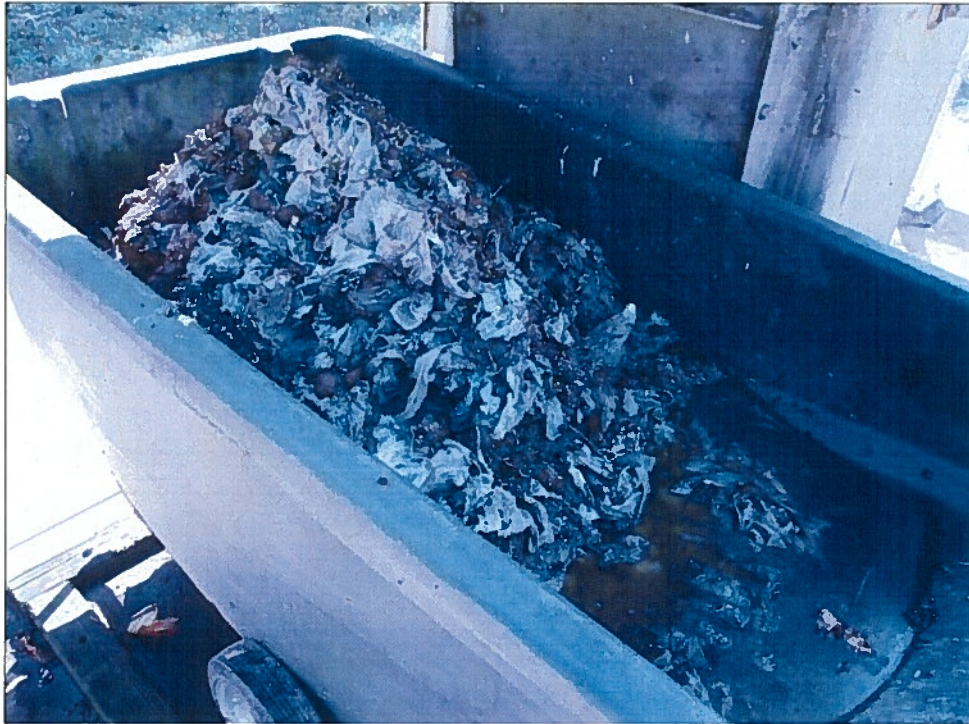
Photograph 7. Fletcher Chapel Pump Station – View of solids from pump station screening.

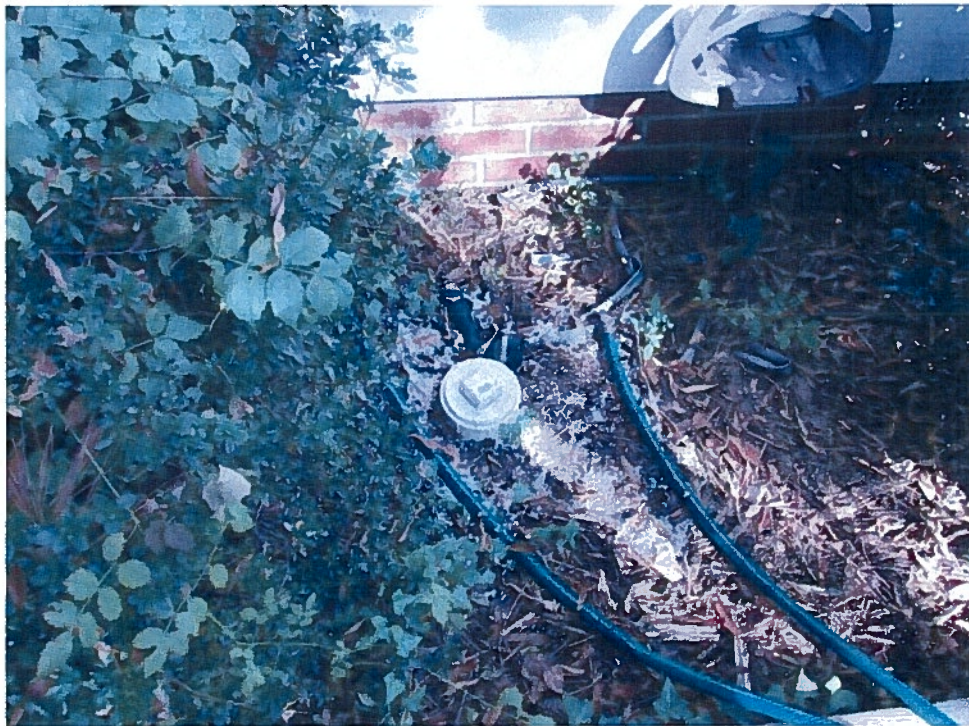
Additionally the EPA Inspection Team observed that the City did not clean up building backup SSOs during the inspection. Specifically, the City did not clean up the SSO at 1702 Forest Road after clearing the blockage which caused the overflow. Instead, the City crews instructed the homeowner that he should clean up the area and disinfect it with bleach.

Photograph 24. 1702 Forest Road – View of overflowed sewage at residential building.

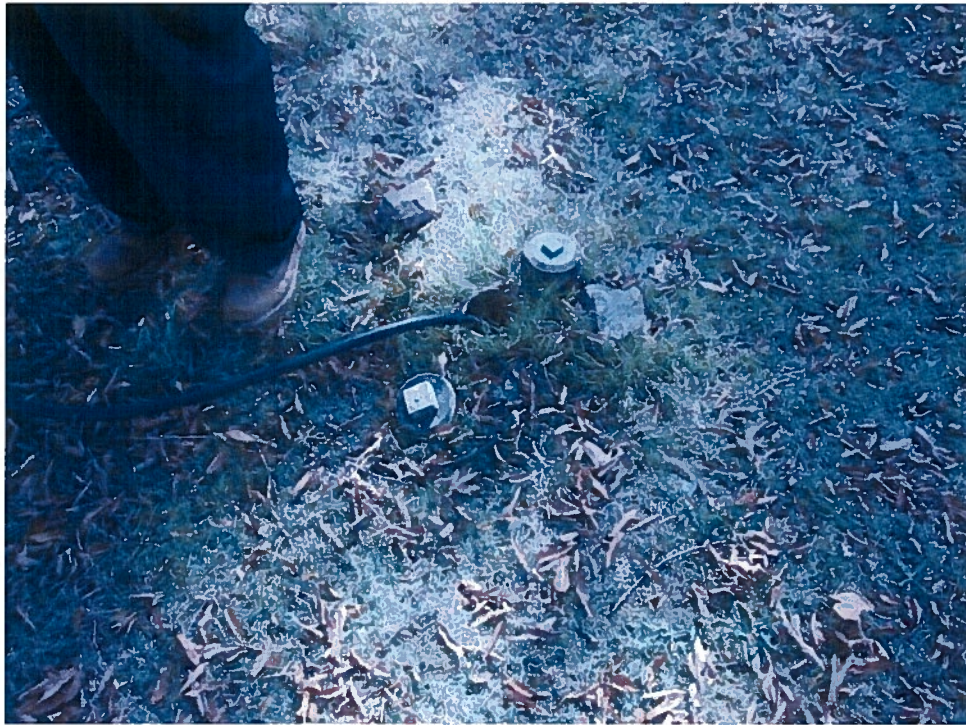
Photograph 25. 1702 Forest Road – View of city cleanout used to clear blockage.

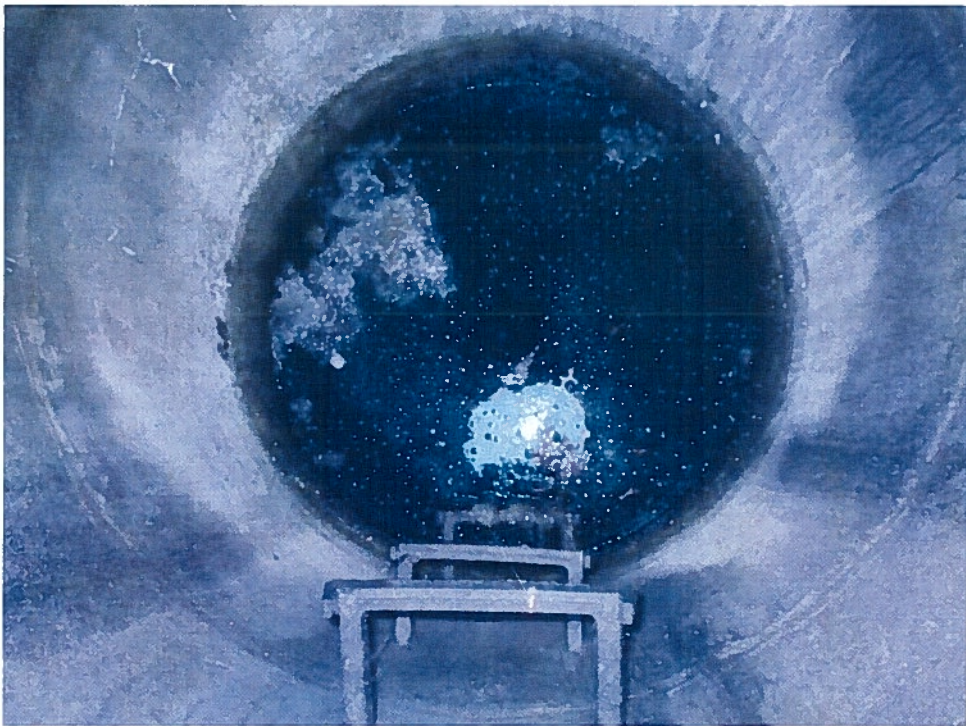
Charlestown Road Sewer Surge	10/24/12 2:00 p.m.	26-27	There was a blockage in a sewer line which caused a surcharged manhole. The City cleaning crew ran the jetter out at 3,000 psi and pulled it back at 4,000 psi. There were rags wrapped around the nozzle when it was pulled out of the sewer.
West Point on the Eno Park	10/25/12 9:30 a.m.	28-34	The EPA Inspection Team inspected a sewer line that runs parallel to the Eno River in the West Point on the Eno Park. The City crews accompanying the EPA Inspection Team stated that the line frequently surcharges and that the crews had been there several times previously for overflows from the manholes on the sewer line. The manholes that were inspected during the inspection all showed signs of recent and/or frequent surcharging.

Photograph 26. Charlestown Road Sewer Surcharge - View of surcharged manhole.

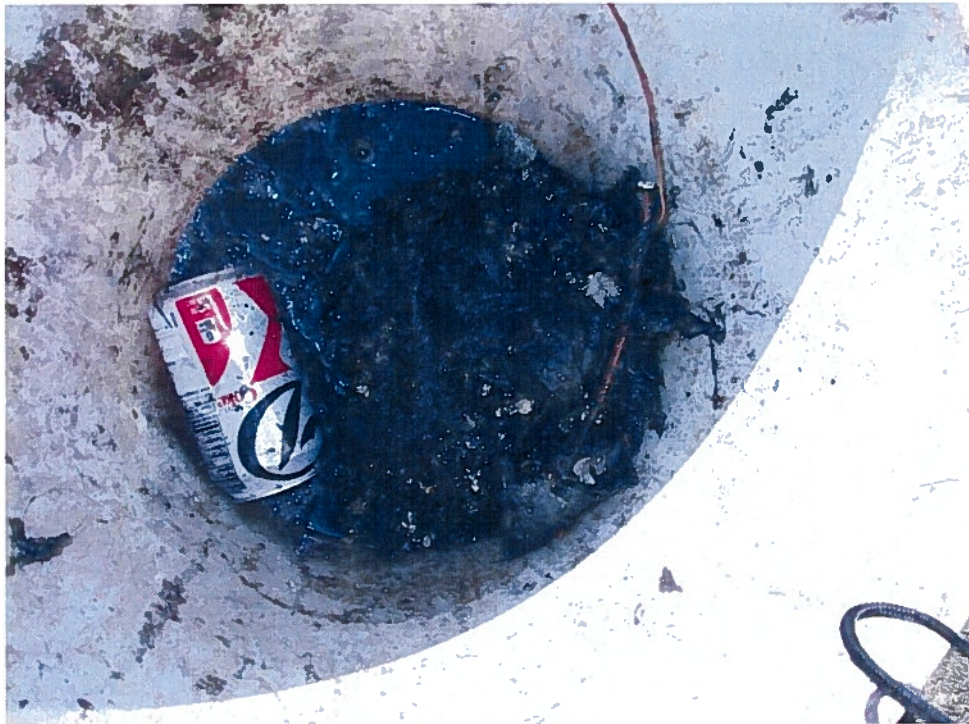
Photograph 27. Charlestown Road Sewer Surge - View of material removed from sewer that was causing the surge.

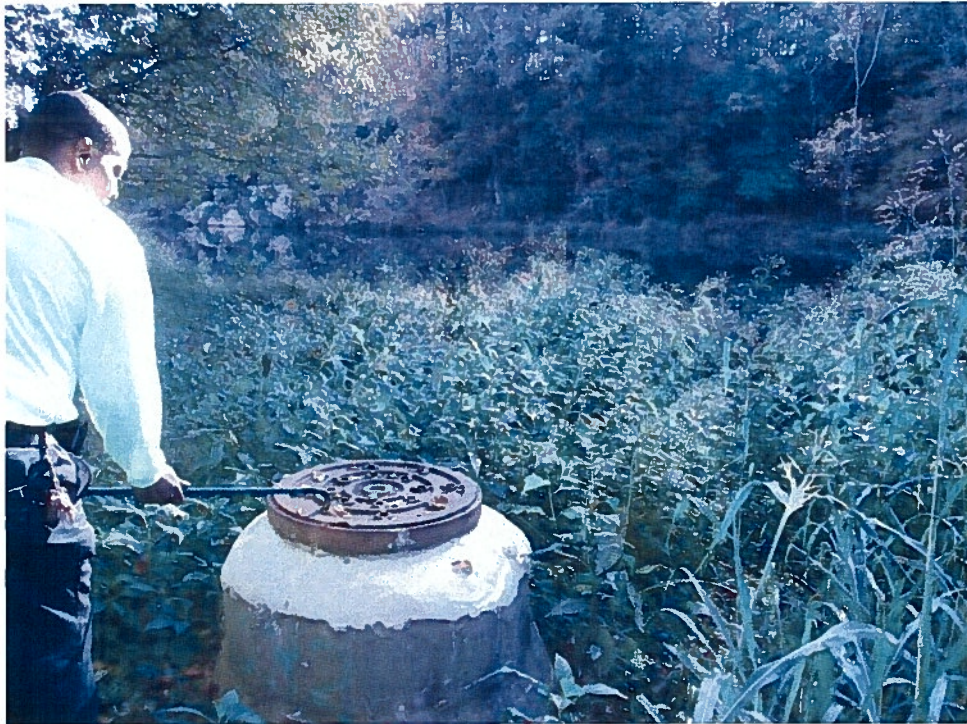
The EPA Inspection team inspected a sewer main which runs parallel to the Eno River at West Point on the Eno Park in northern Durham. The manholes for the sewer main showed signs of recent surcharging up to and over the manhole covers (see Photographs 28-30). The City's maintenance staff stated that the sewer main has been known to overflow in the past during wet weather events. PG reviewed the Cityworks database for overflows reported at this location and found two customer complaints relating to this sewer main (see Table 4). It should be noted that the sewer main is in a park along a walking trail and not in a populated area. As such, overflows during wet weather would typically go unnoticed unless there are people walking the path during the wet weather event.

Photograph 28. West Point on the Eno Park – View of manhole showing evidence of surcharging. Note the manhole is approximately 20 feet from the Eno River.

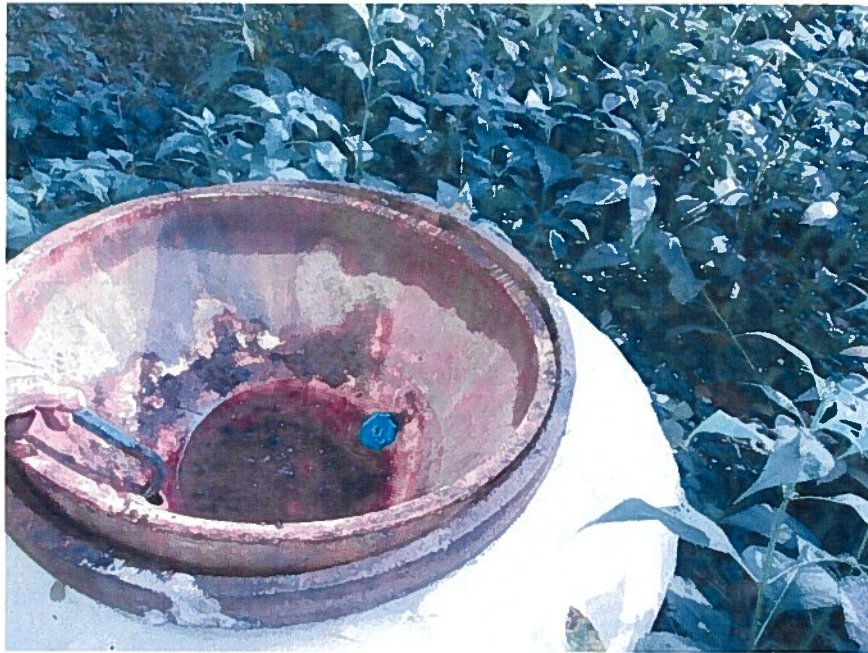
Photograph 29. West Point on the Eno Park – View of manhole shown in Photograph 28 after removal of the manhole cover. Note the wastewater debris accumulated in the manhole insert.

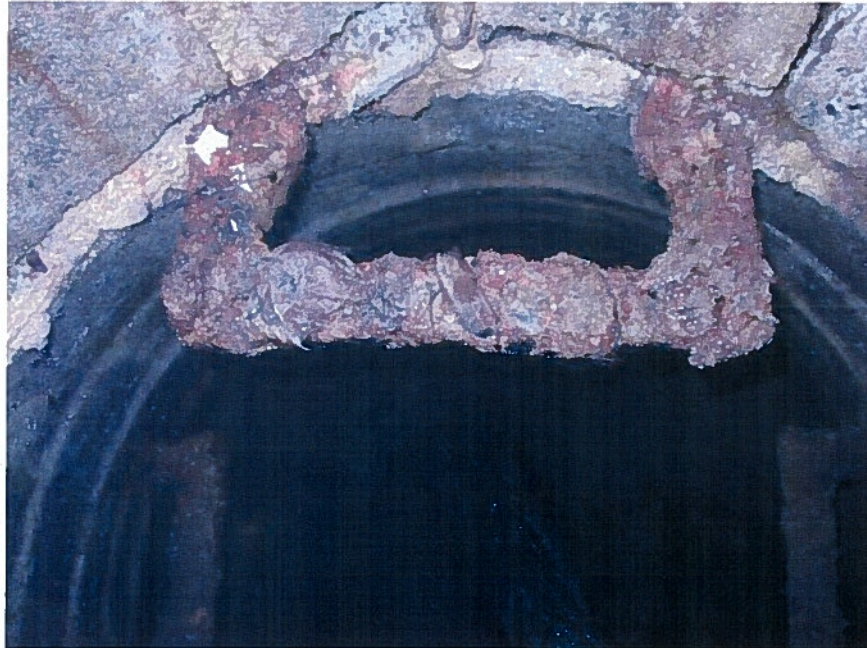
Photograph 30. West Point on the Eno Park – View of manhole shown in Photograph 28 after removal of the odor control insert. Note the accumulation of debris on the top ladder rung indicating frequent surcharging.

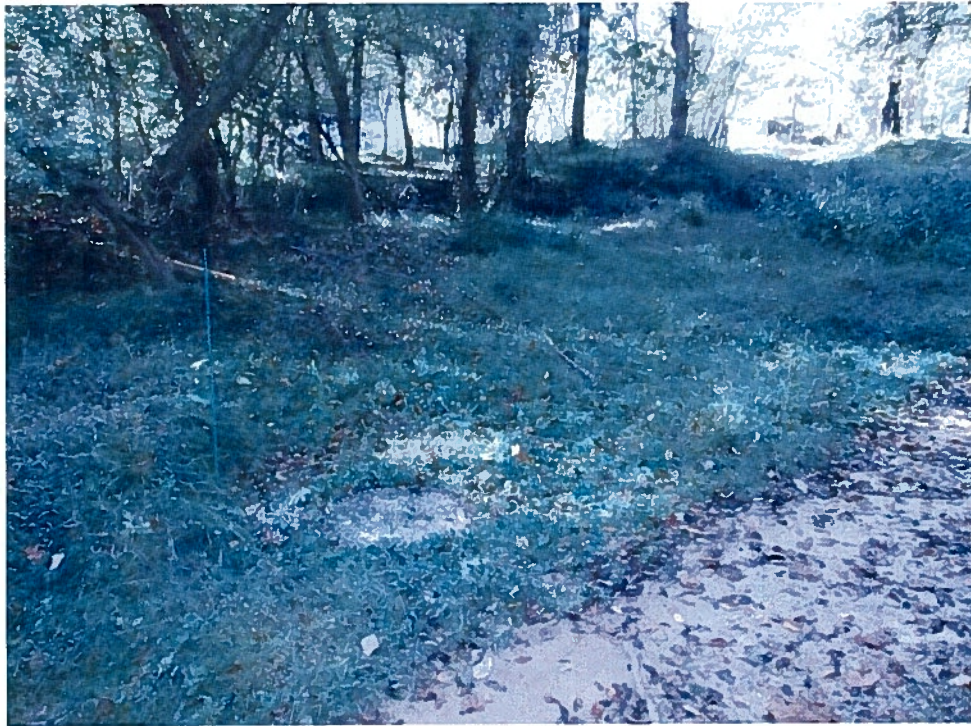
Photograph 31. West Point on the Eno Park – View of additional manhole approximately 50 feet from the Eno River.

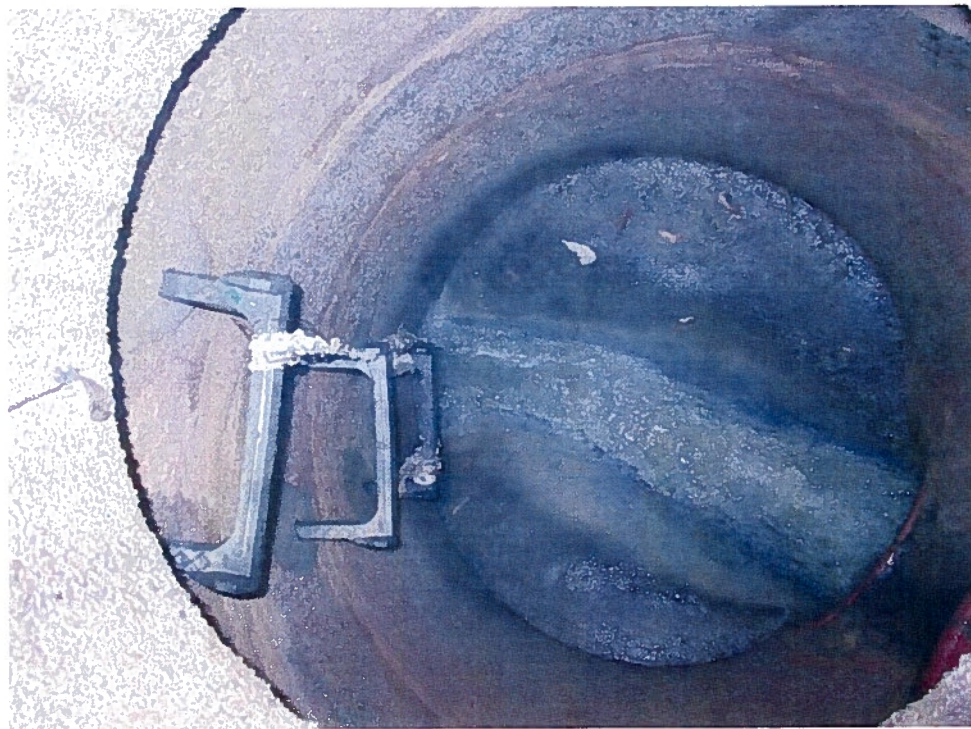
Photograph 32. West Point on the Eno Park – View of manhole shown in Photograph 31 after removing manhole cover. Note the accumulation of debris on the top ladder rung indicating surcharging.

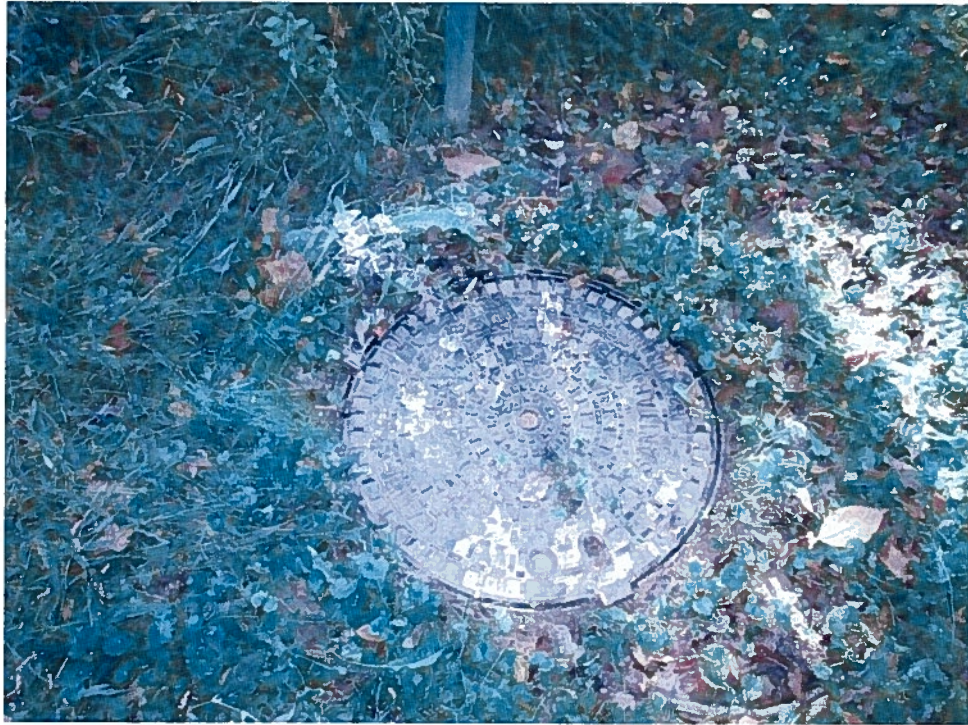
Photograph 33. West Point on the Eno Park – View of additional manhole approximately 40 feet from the Eno River.

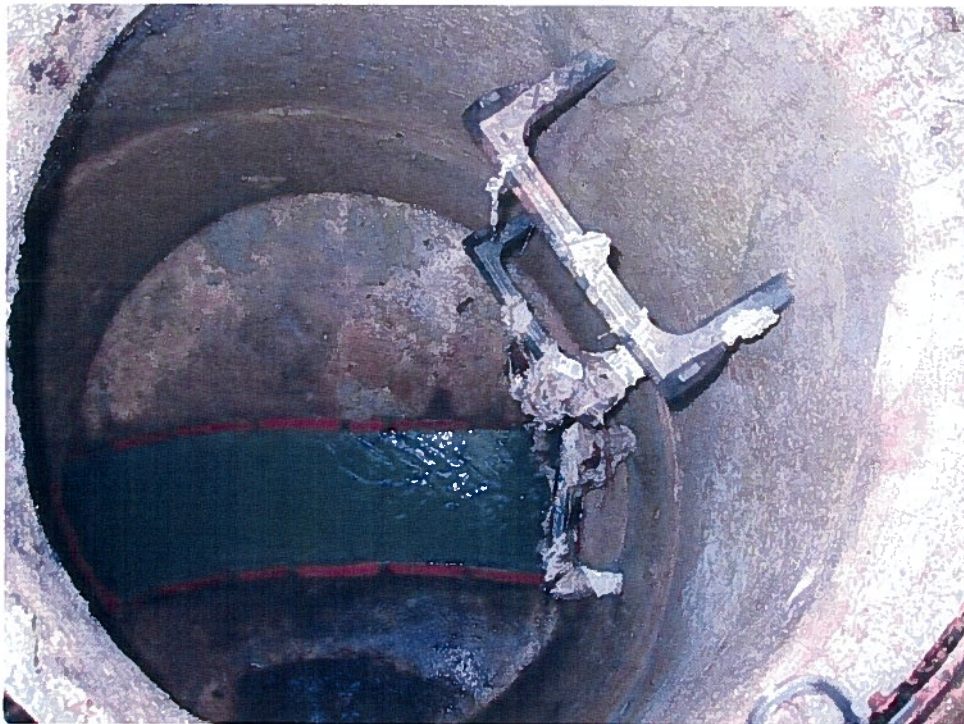
Photograph 34. West Point on the Eno Park – View of manhole shown in Photograph 33 after removing manhole cover. Note the accumulation of debris on the top ladder rung indicating surcharging.
